Installation Manual for NoLimit Vmax Unit IV – M177DE40AL

Mercedes C63 AMG 476PS/350kW / C63S AMG 510PS/375kW

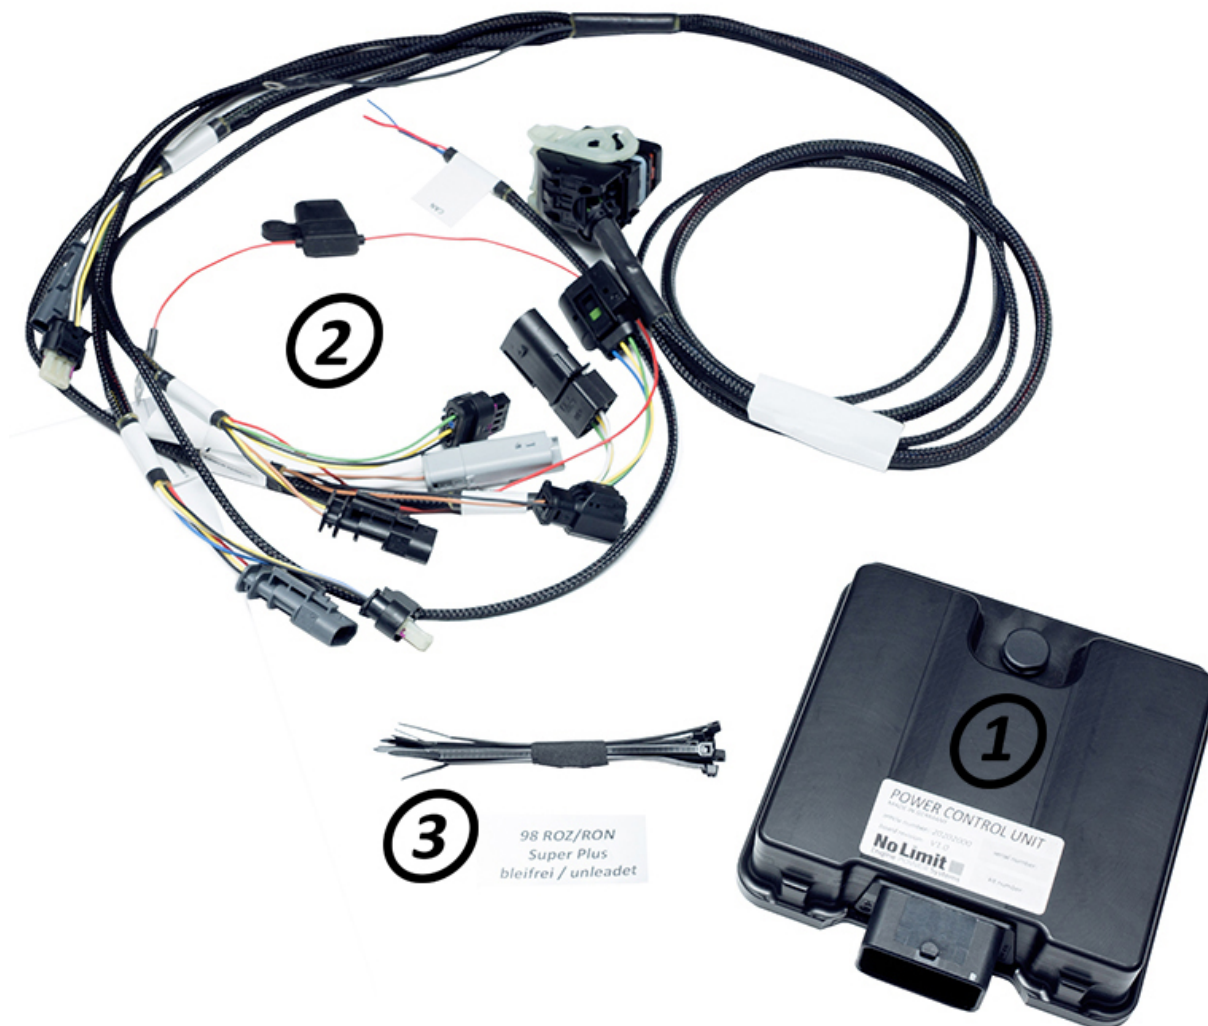
NoLimit Vmax Unit IV consists of:

(The illustration is an example)

1. Vmax Unit IV
2. Plug&Play-cable harness
3. assembly material

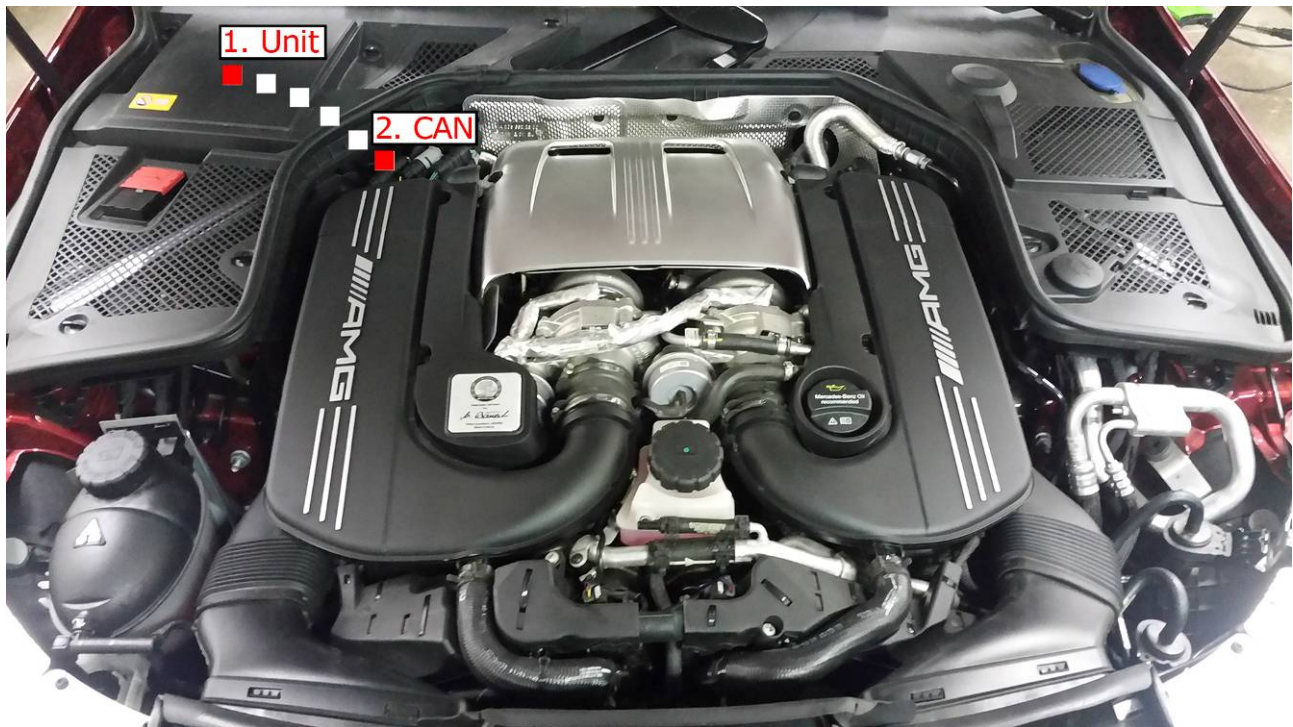
The NoLimit Vmax Unit IV is installed in the engine compartment. The cable harness is plugged in-between the reversing sensors/actuators.

1. Vmax Unit IV
2. CAN

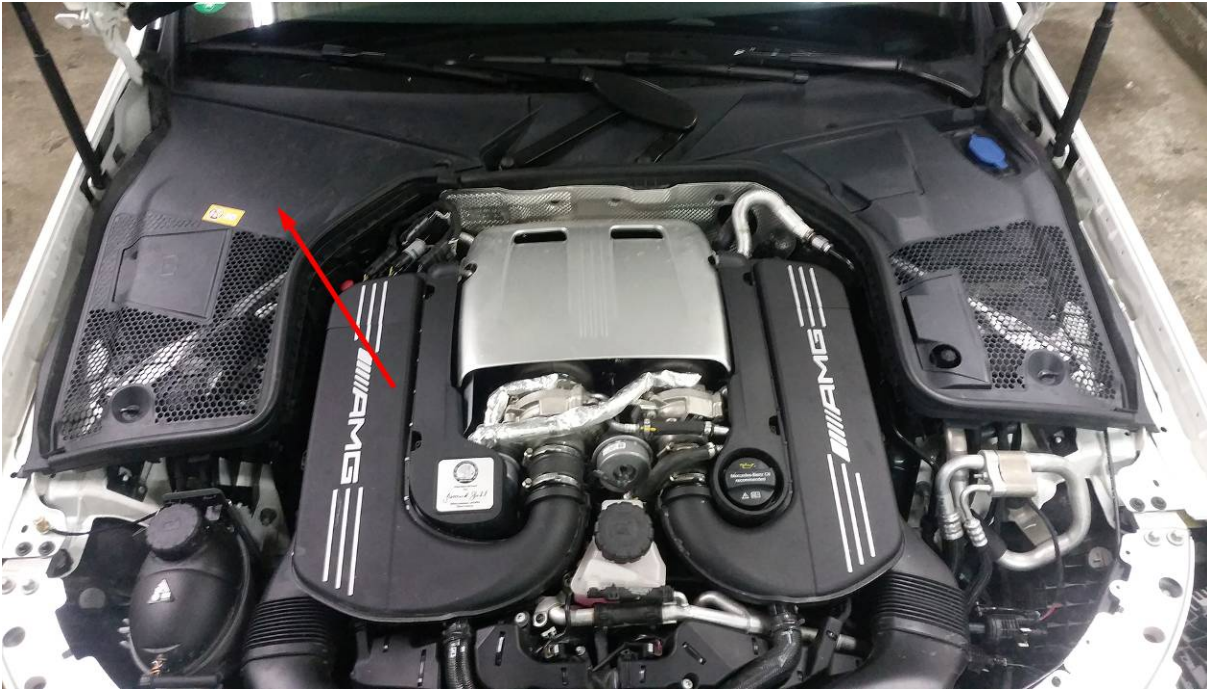
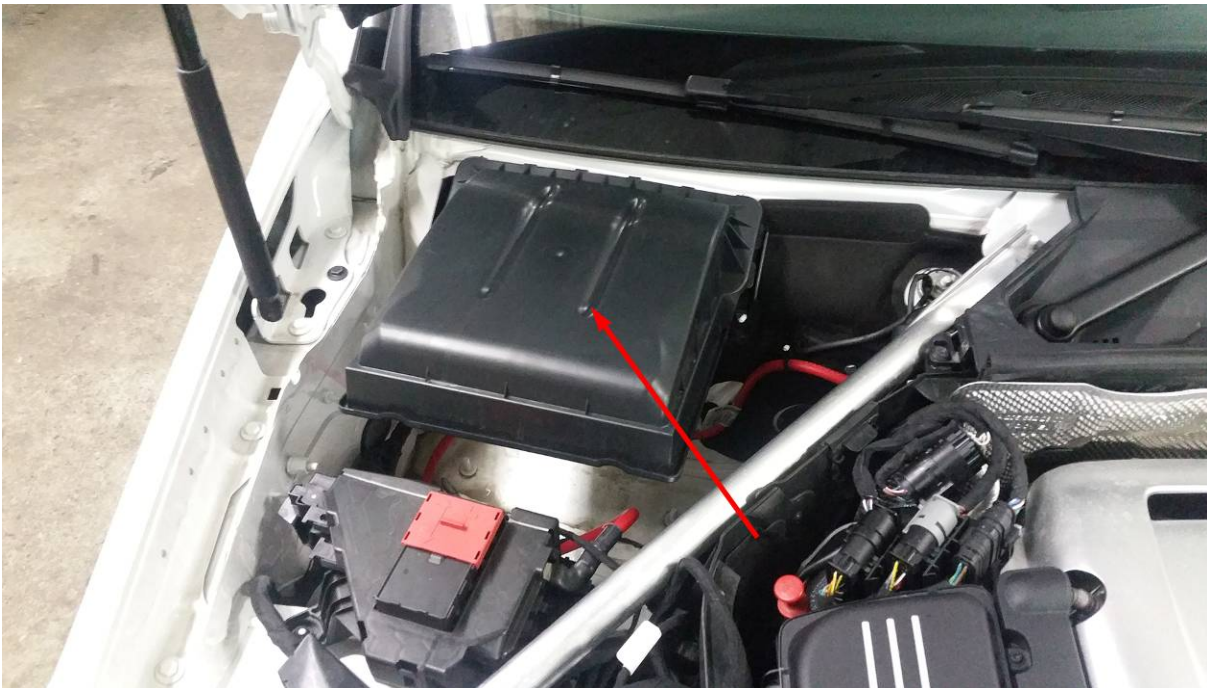
Step 1: remove left cover and interior filter.

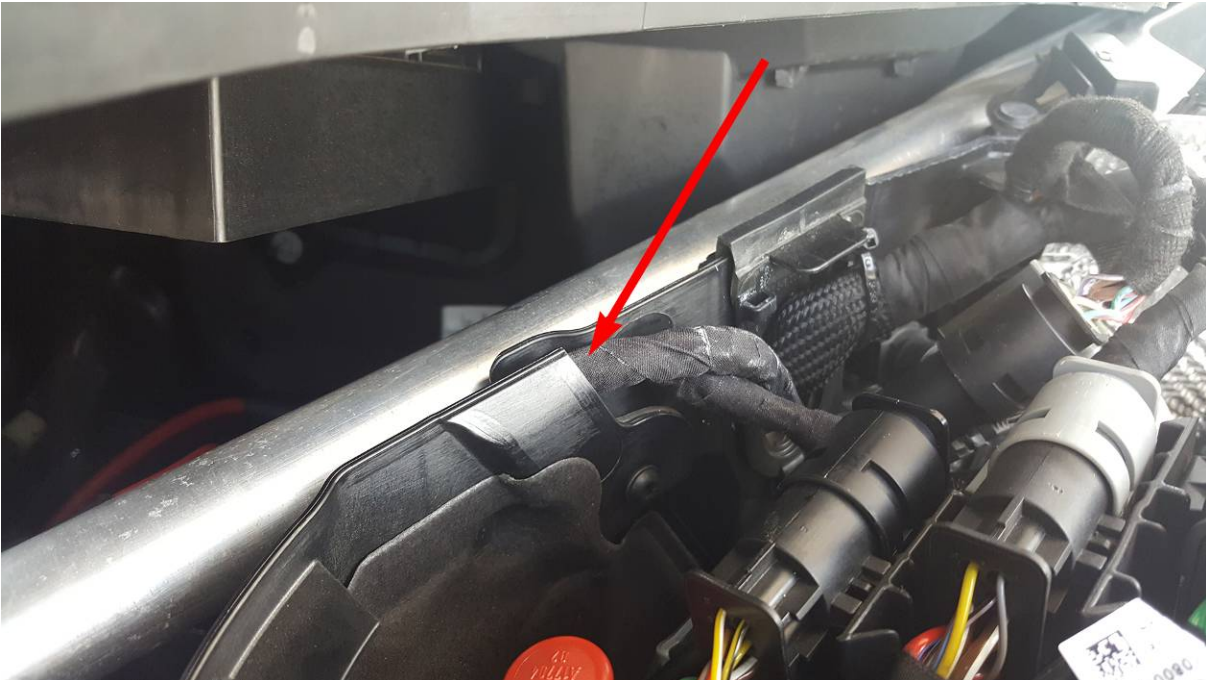
Step 2: lead CAN cables through the plastic separation.

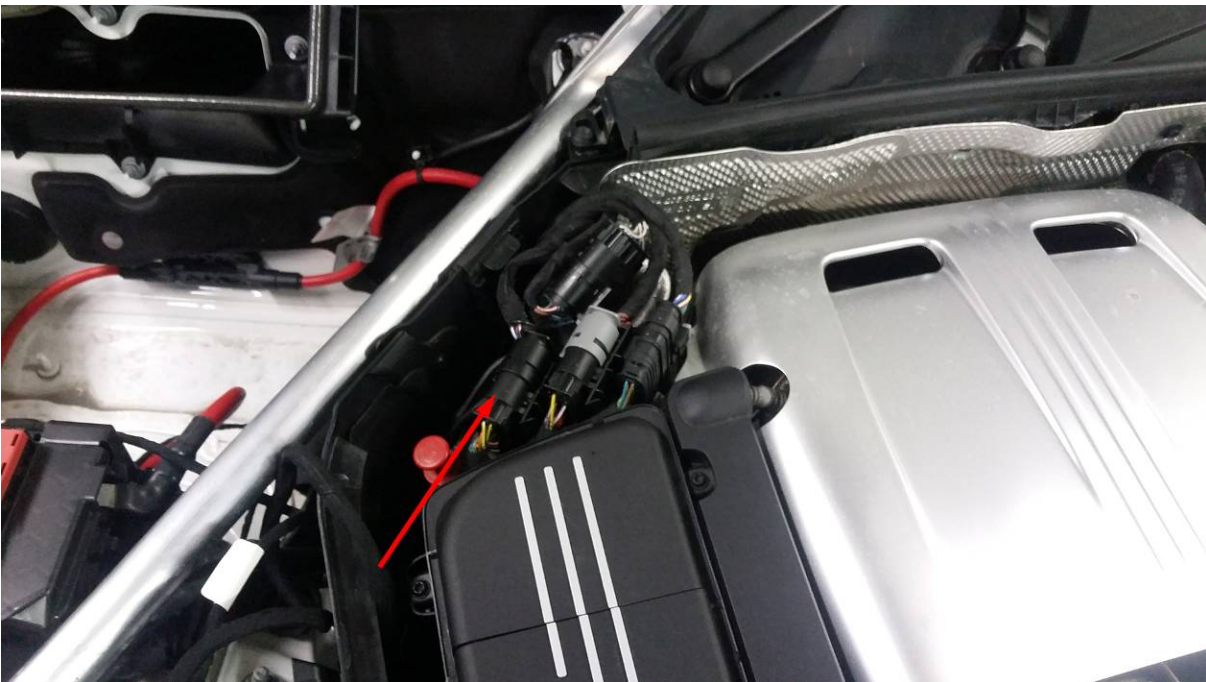
Step 3: between CAN stuck on the left plug.

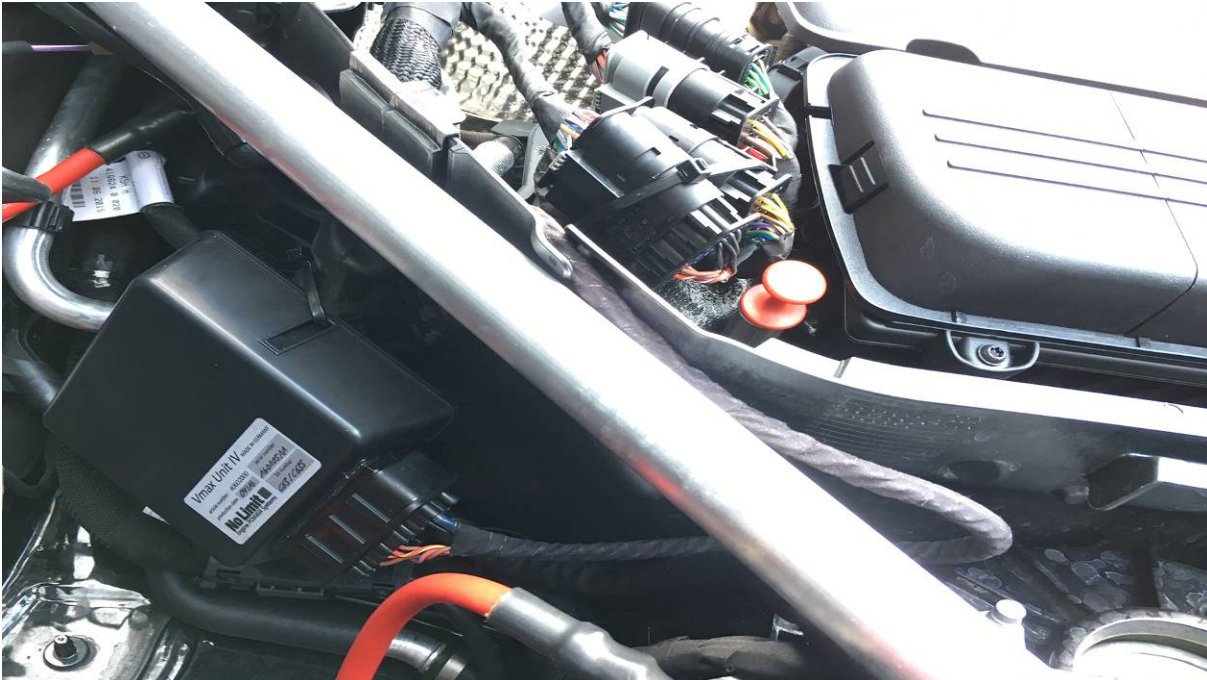
Step 4: connect Vmax Unit IV with cable harness.
